Wilson River Highway (OR6) MP 32 to 37 Landslide Investigations and Planning

Region 2, Geo/Hydro/HazMAT Unit

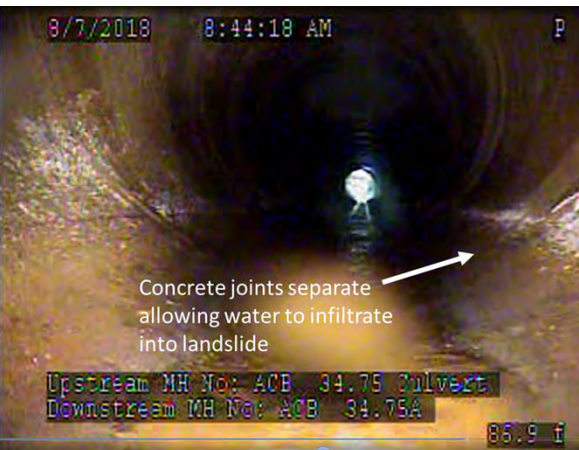
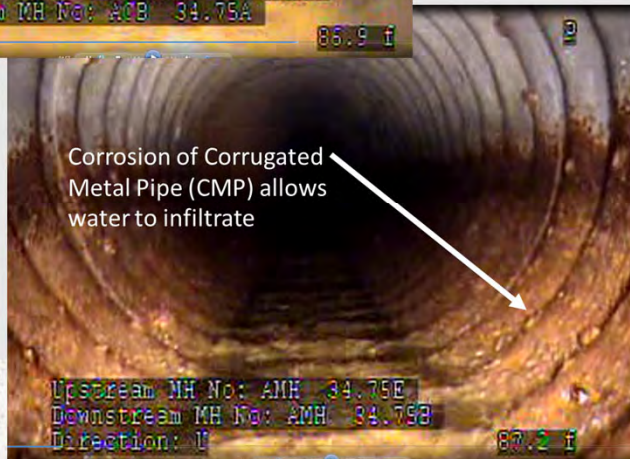
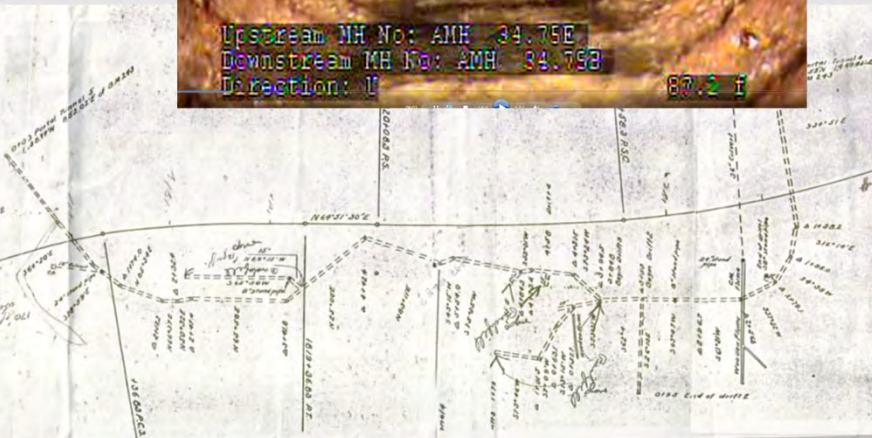
1956 Drainage Tunnels

- Drainage tunnels installed by specialty mining crews to facilitate drainage around the active landslides at MP 34.8.
- Tunnels lined with concrete and corrugated pipes.
- Tunnels now collapsing forming sink holes at the surface.
- Effectiveness of these drainage tunnels is now reduced.

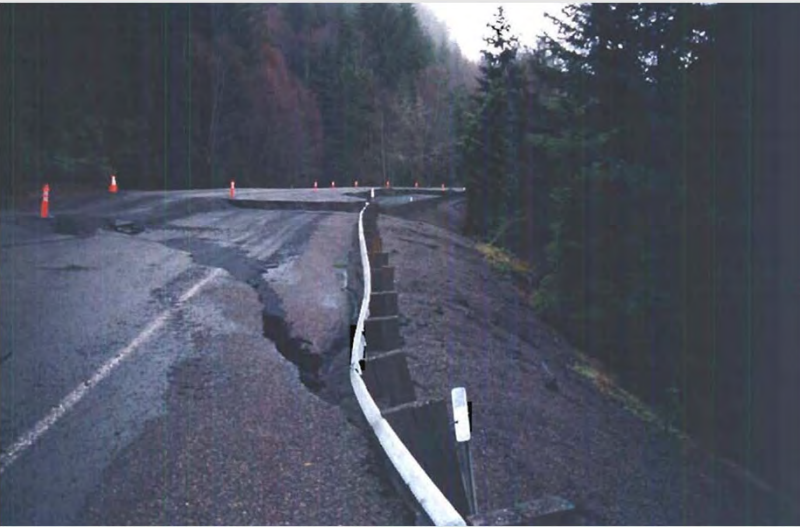
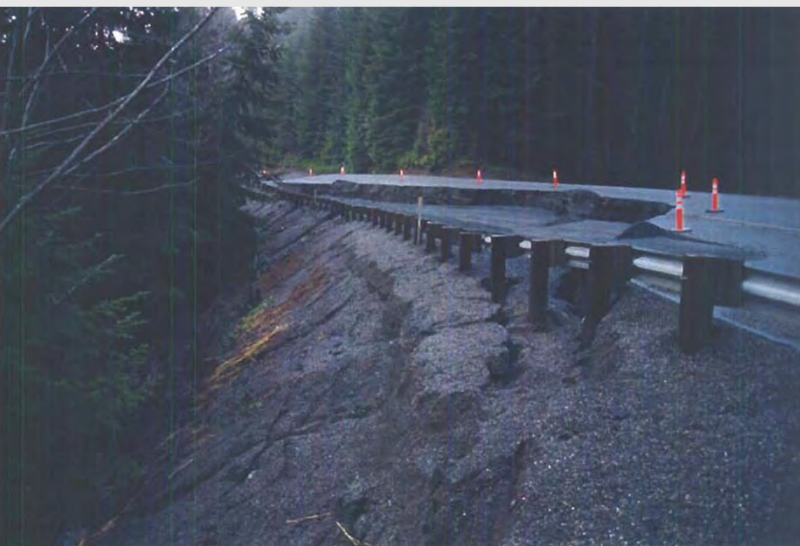
1996 Flood Damage

- 1996 associated rain events caused widespread damage along the OR6 corridor.
- Several partial roadway collapses occurred.
- Example images from MP 33.3.

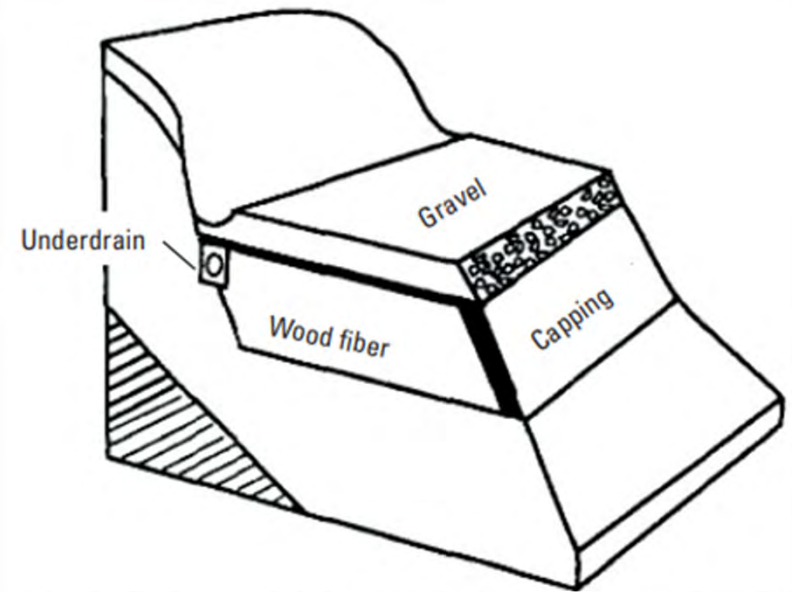
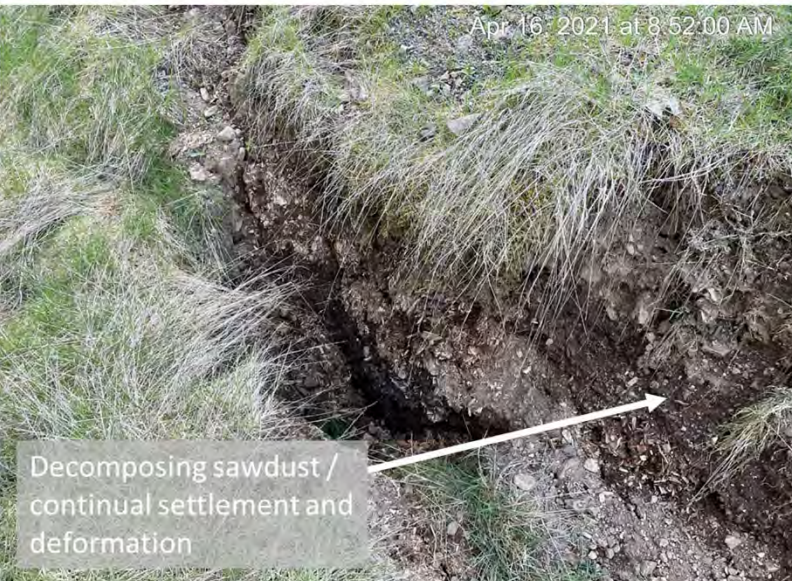
Lightweight Fill Repairs

- Lightweight fill materials used to reduce loading on these landslide features during repair efforts circa 1996 and 2010.
- In accordance with standard practice of the time, lightweight fill composed of wood fiber or sawdust was used.
- This material is now decomposing causing continued settlement of the pavement.

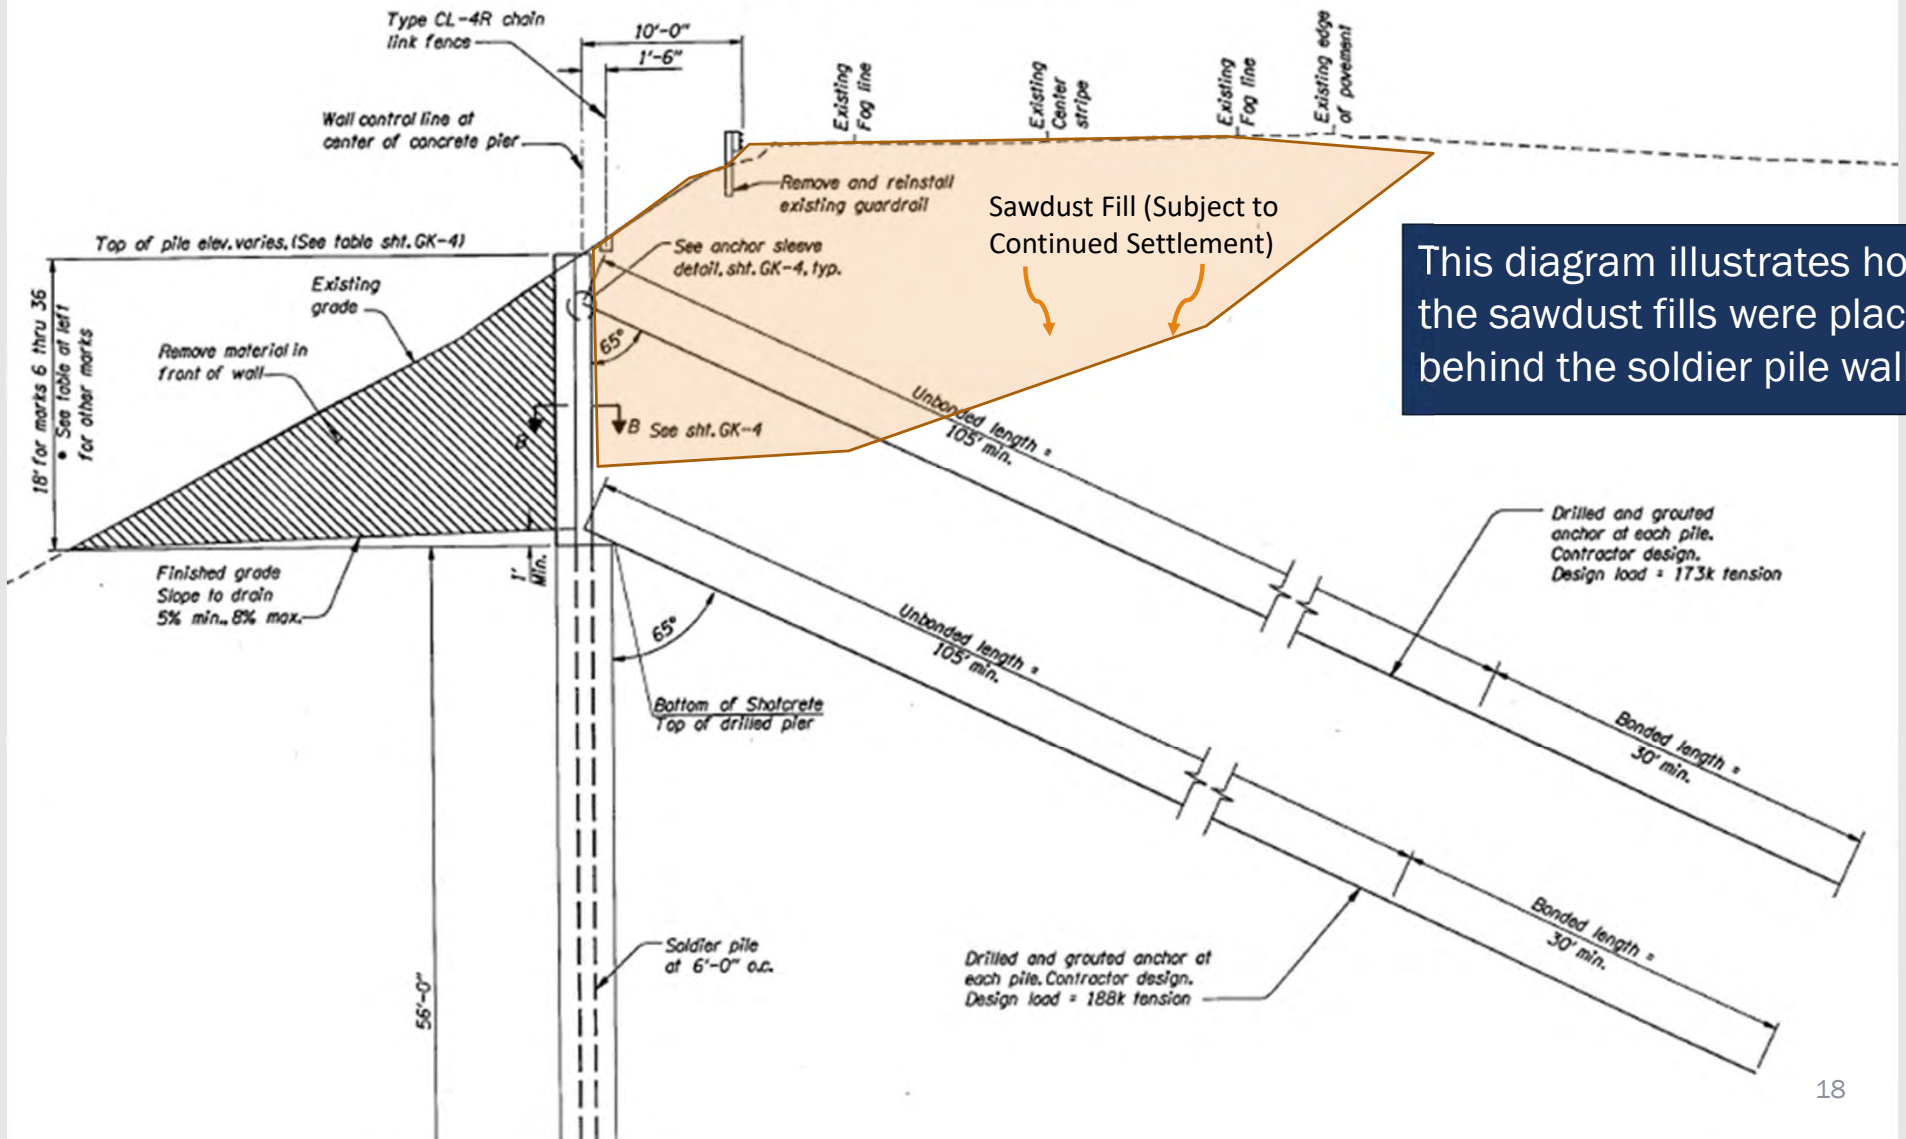
ANCHORED SOLDIER PILE WALL

This diagram illustrates how the sawdust fills were placed behind the soldier pile walls.

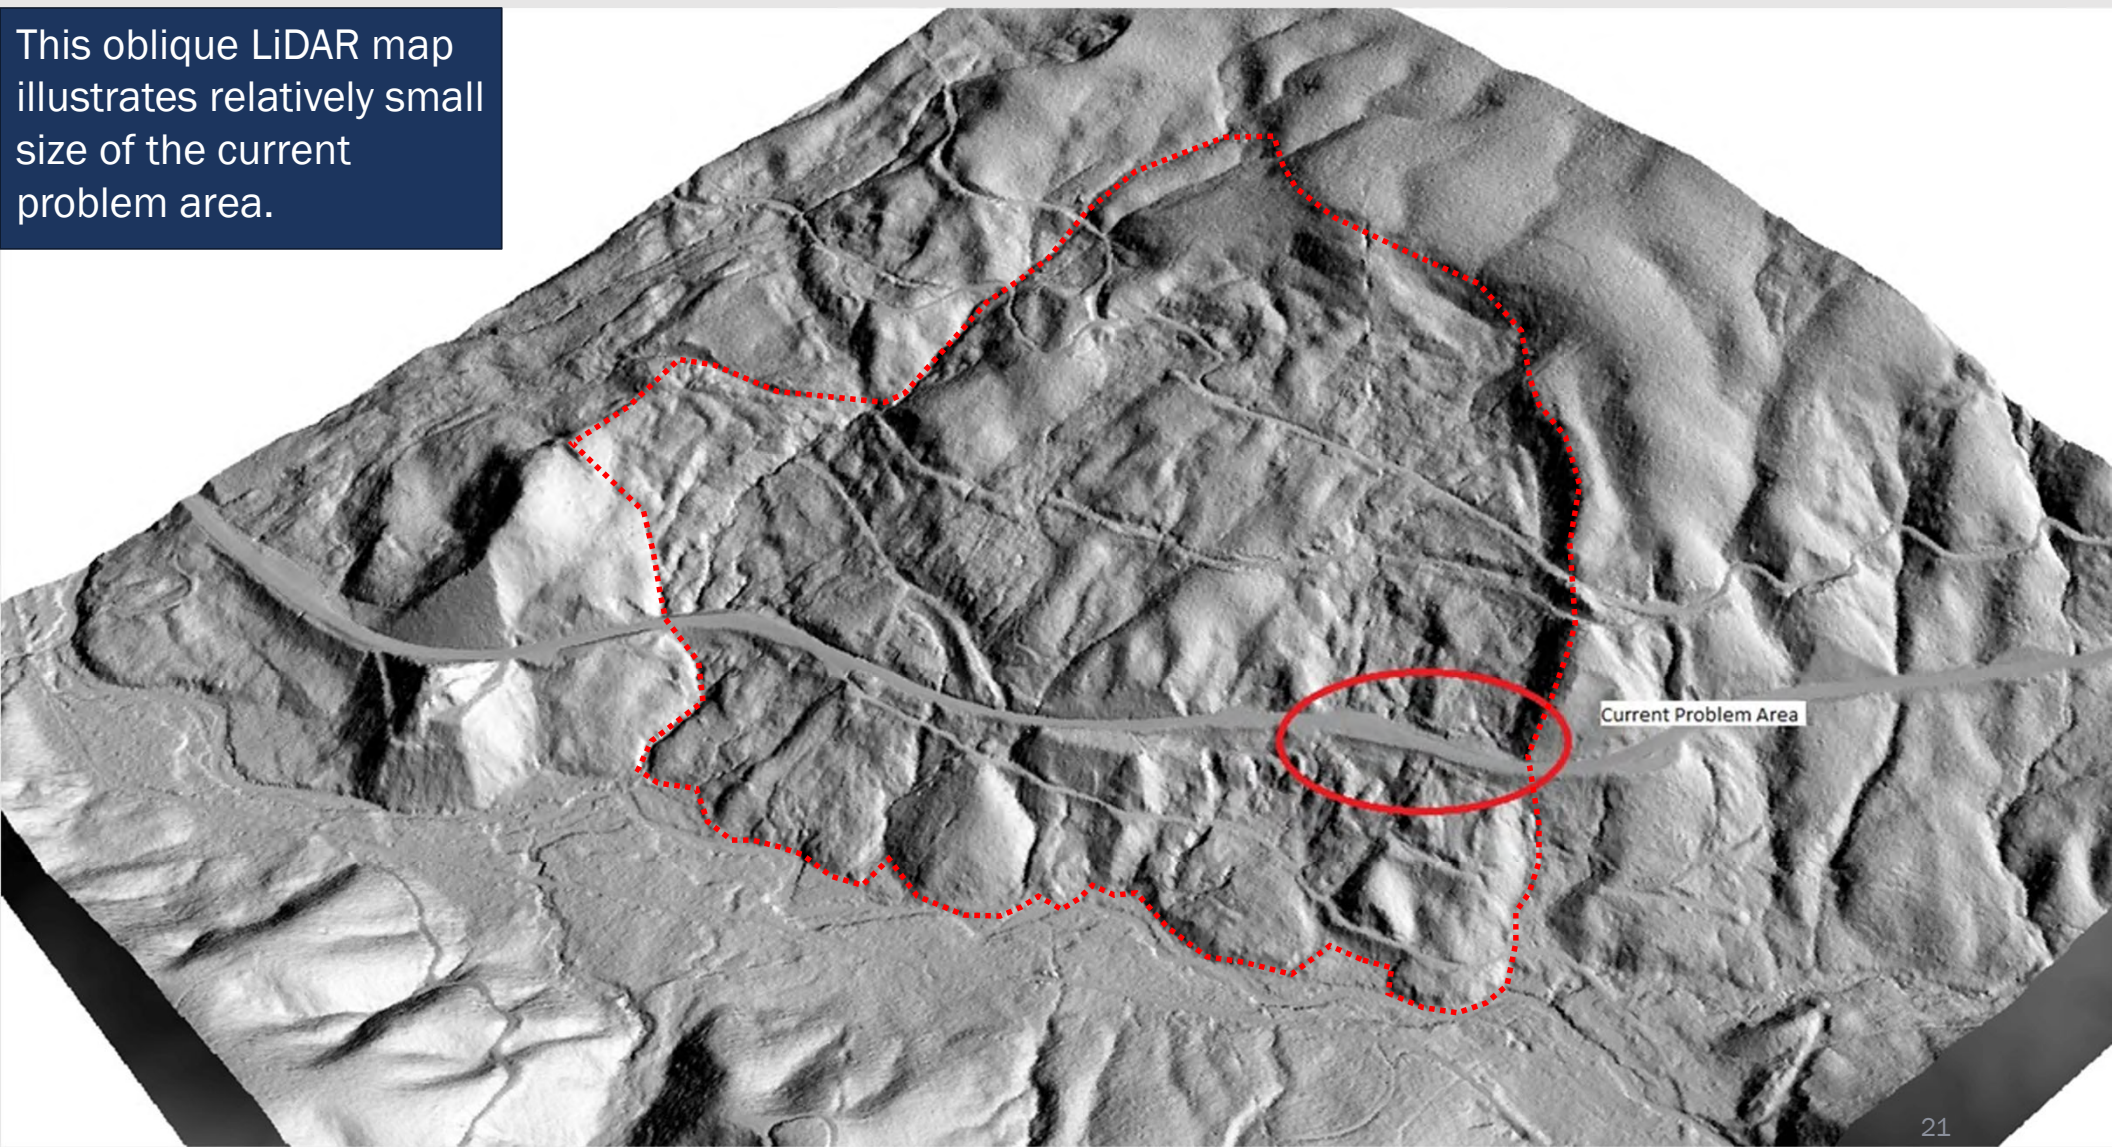
Arrow depicts approximate location
of current problem area at MP 34.8

This oblique LiDAR map illustrates relatively small size of the current problem area.

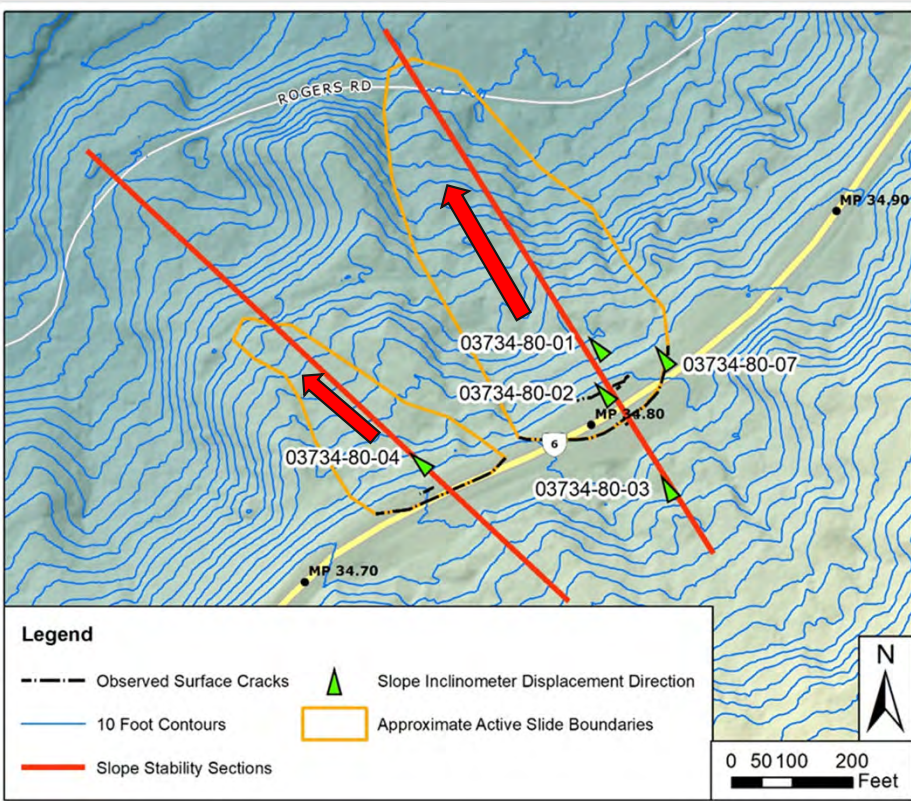
- Slide comprised of two active lobes.
- West lobe is about 275 feet wide.
- East lobe is about 310 feet wide.
- West slide instrumentation indicates depth of movement at 32 feet bgs, just above contact with landslide debris and bedrock.
- East slide instrumentation indicates depth of movement at 37 feet bgs, and 48 feet bgs, just above contact with landslide debris and bedrock.
- Deep basal shear zone (i.e. >30 ft.) dramatically increases repair costs.

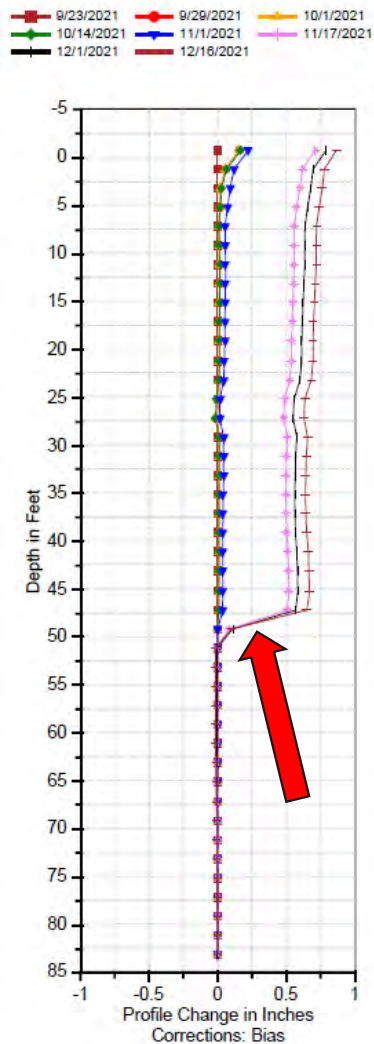
OR6 03734-80-02 A

- Rates of movement indicate pulses or surges on the order of 0.04 to as much as 0.28 inches per week (winter 2021 / 2022).
- Some instruments abandoned due to excessive movement.
- Example plot shows little movement from 09-23-2021 to 11-01-2021, movement increased by 11-17-2021, and then slowed thereafter.

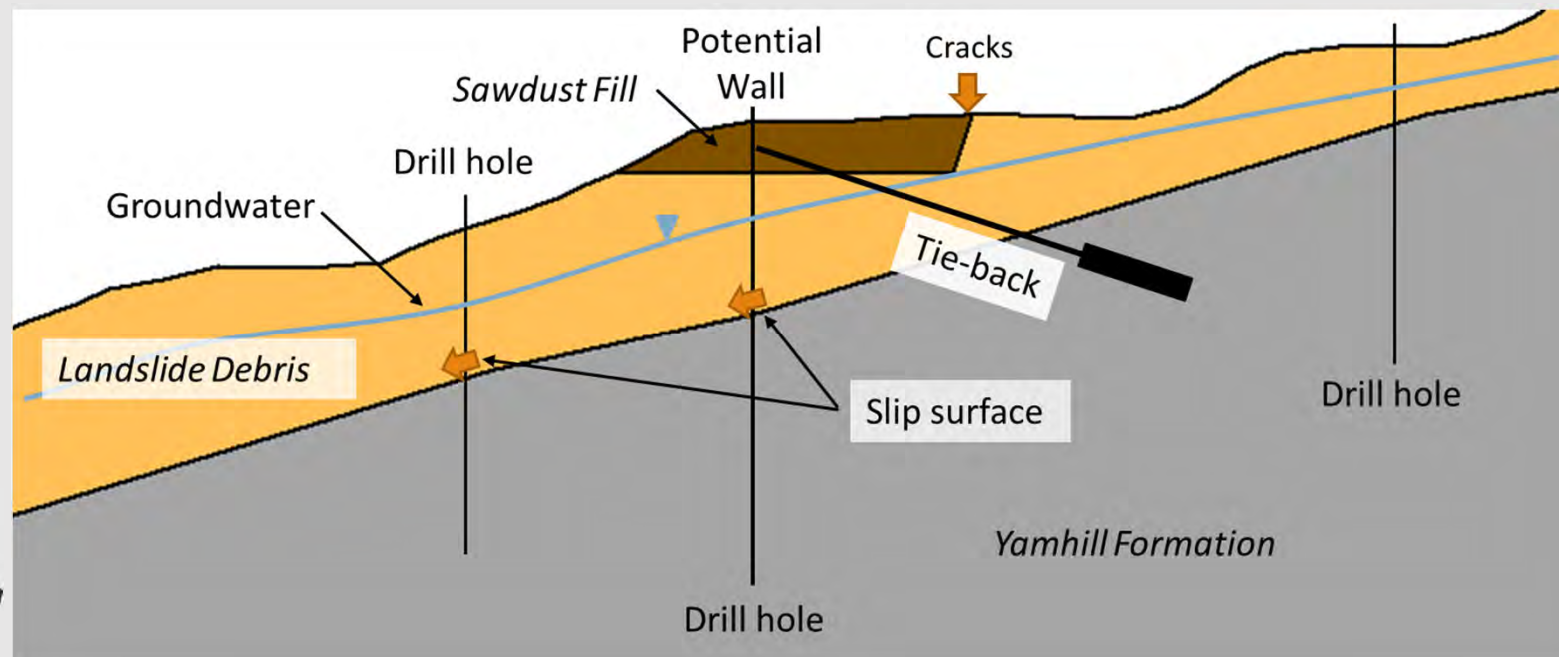
- Preliminary landslide slope stability modeling performed to evaluate feasibility of mitigation alternatives.

Option	Risks	Benefits	Est. Cost ⁽¹⁾
Tie-back Soldier pile wall	More investigation, one continuous wall for both slides, may need two wall lines and multiple rows of tie-backs	Removes sawdust fill, maintains current alignment, less impact to traffic / mobility	Estimated ~\$20 M
Local Highway Realignment	More investigation, reactivation of surrounding landslide(s), alignment alteration, impacts to traffic / mobility	Avoids existing landslide / sawdust fill	Estimated ~\$6 to \$10 M Shift Roadway Upslope and off Active Portion of Slide
Excavate and Replace Highway	More investigation, may still need tie-back soldier pile wall, impacts to traffic / mobility	Removes sawdust fill, maintains current alignment	Estimated ~\$9 to \$15 M Place Large SEM Fill
