Wilson River Highway (OR6) MP 32 to 37 Landslide Investigations and Planning

Region 2, Geo/Hydro/HazMAT Unit

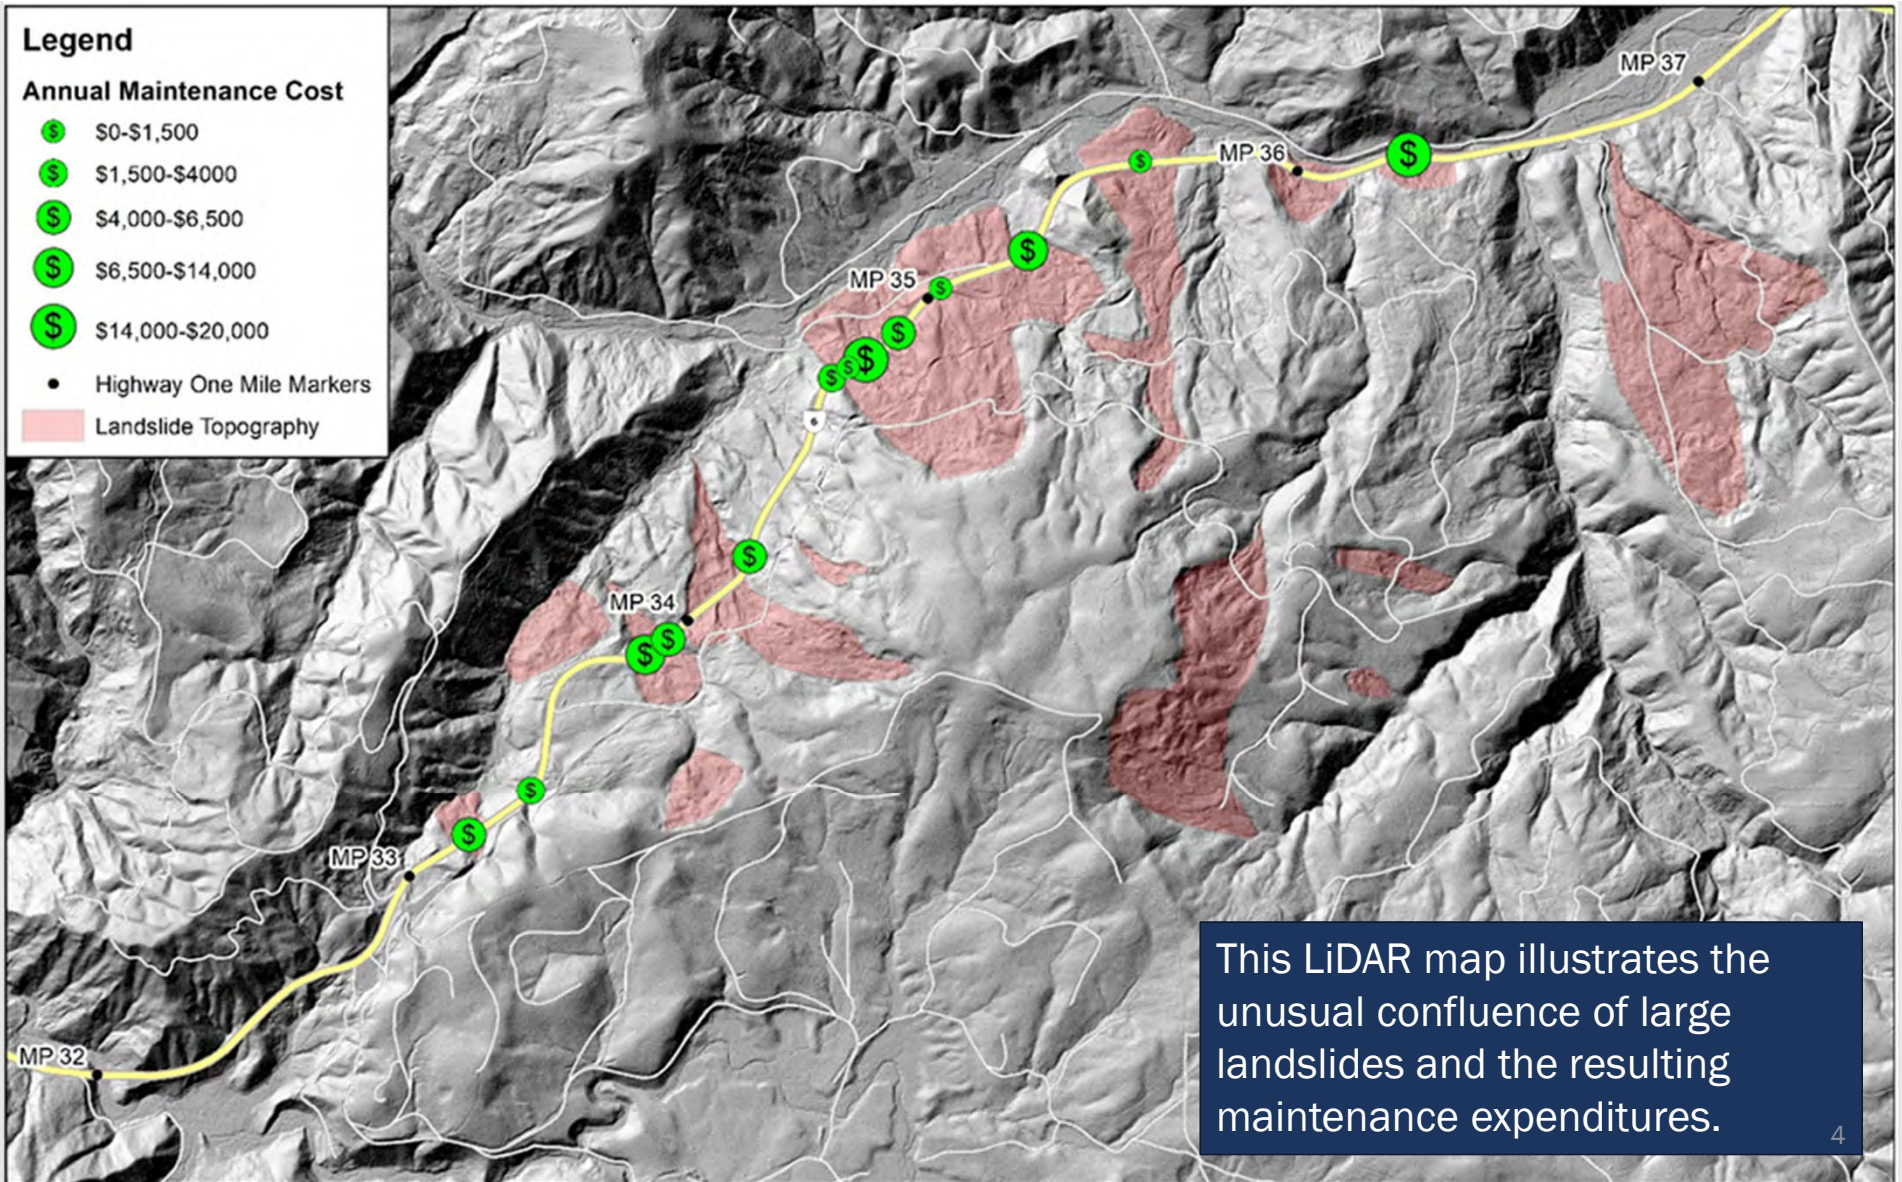
This LiDAR map illustrates the unusual confluence of large landslides and the resulting maintenance expenditures.

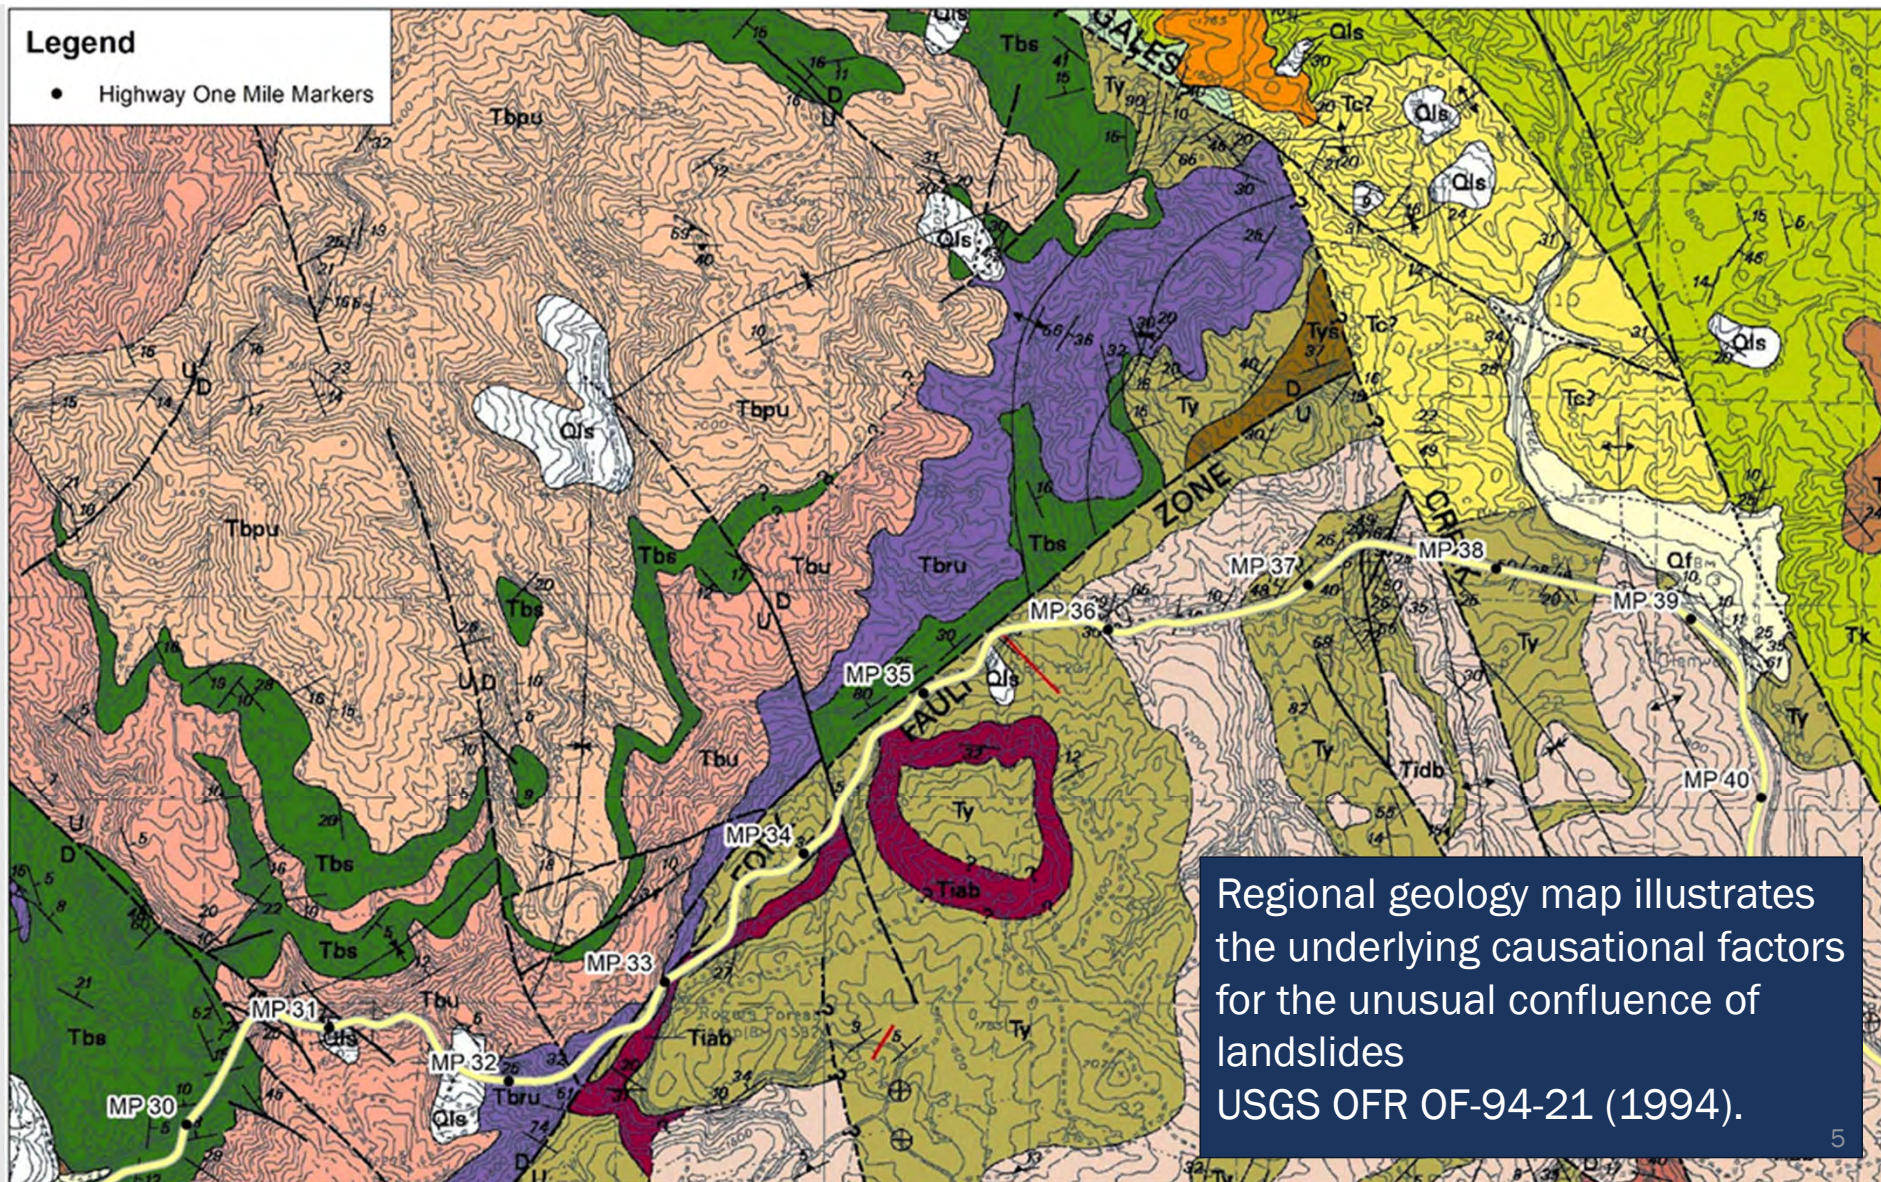
Regional geology map illustrates the underlying causal factors for the unusual confluence of landslides
USGS OFR OF-94-21 (1994).

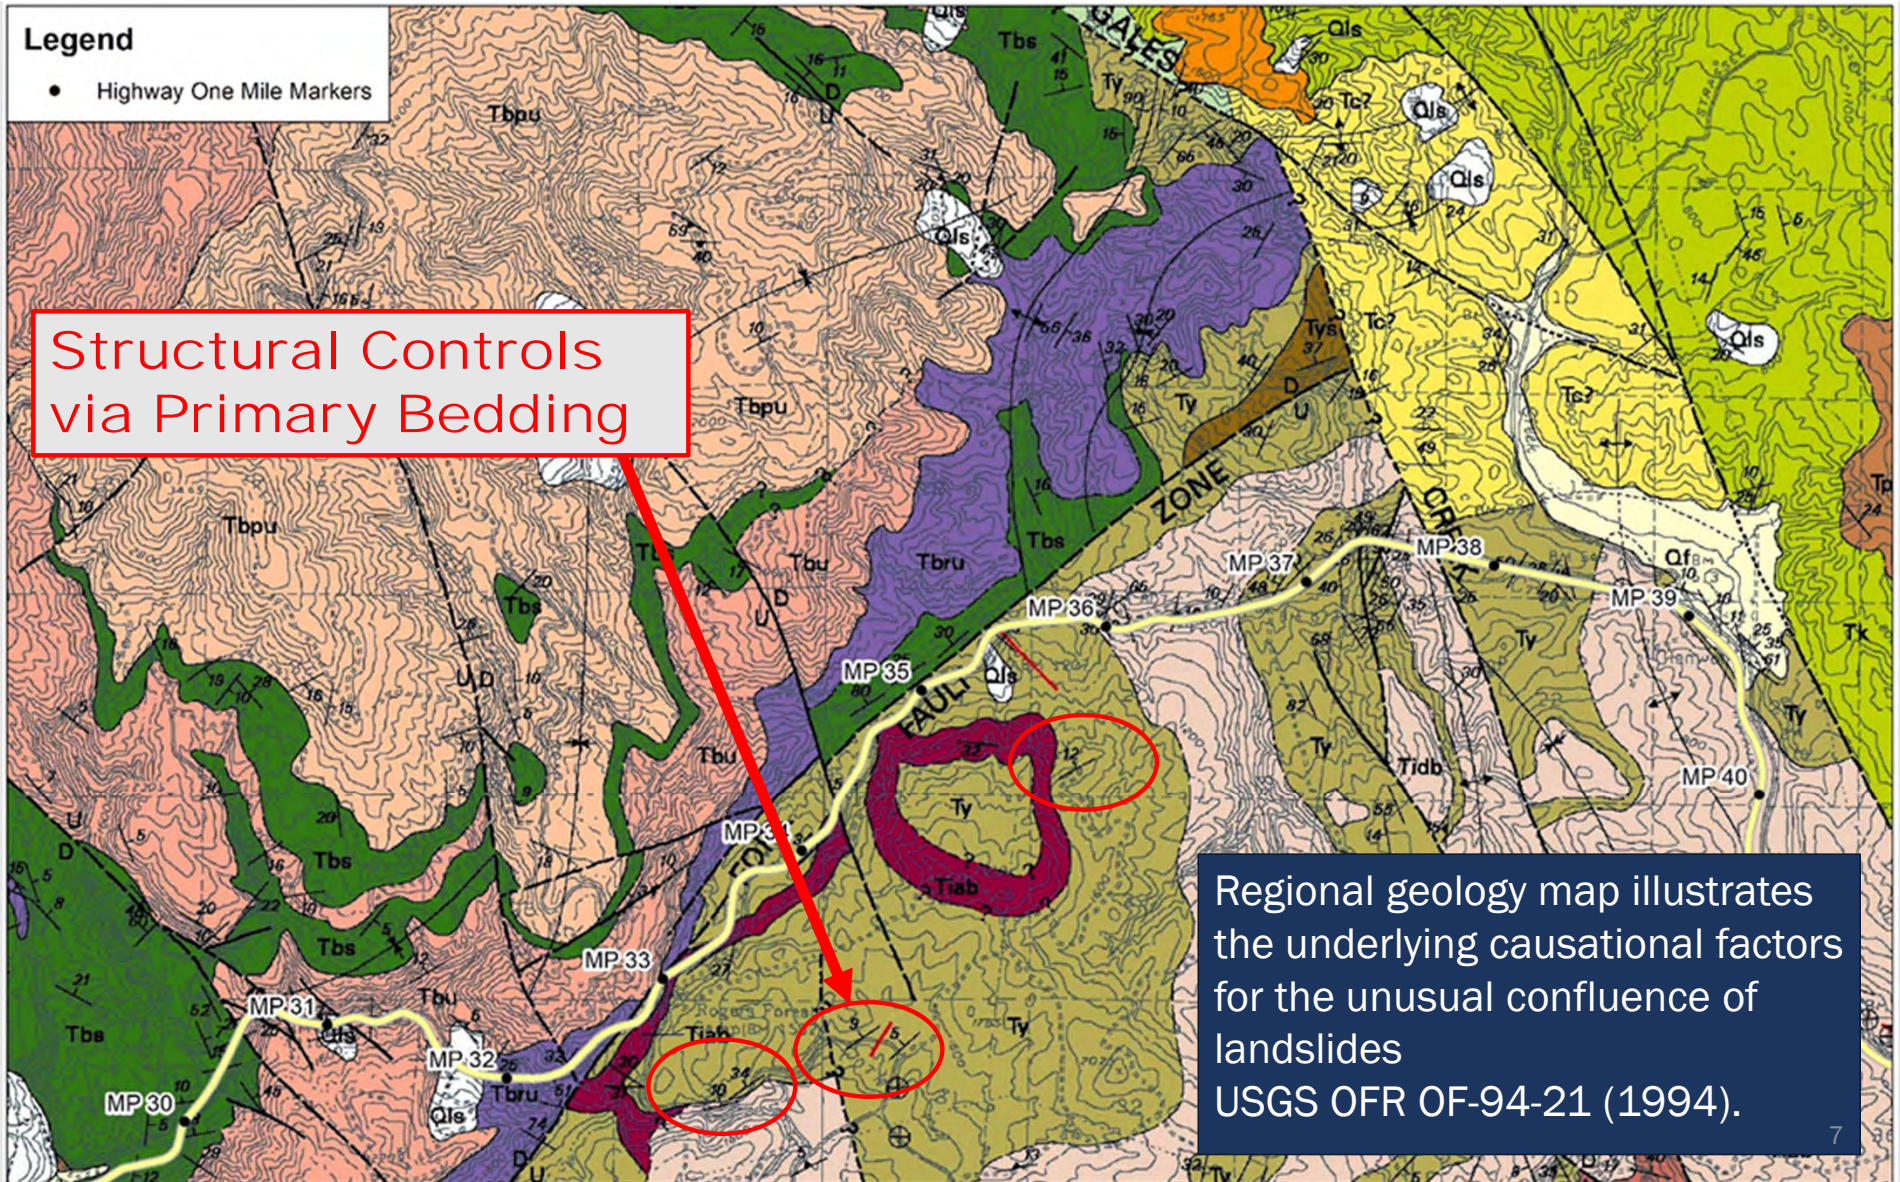
Structural Controls
via Primary Bedding

Regional geology map illustrates the underlying causal factors for the unusual confluence of landslides
USGS OFR OF-94-21 (1994).

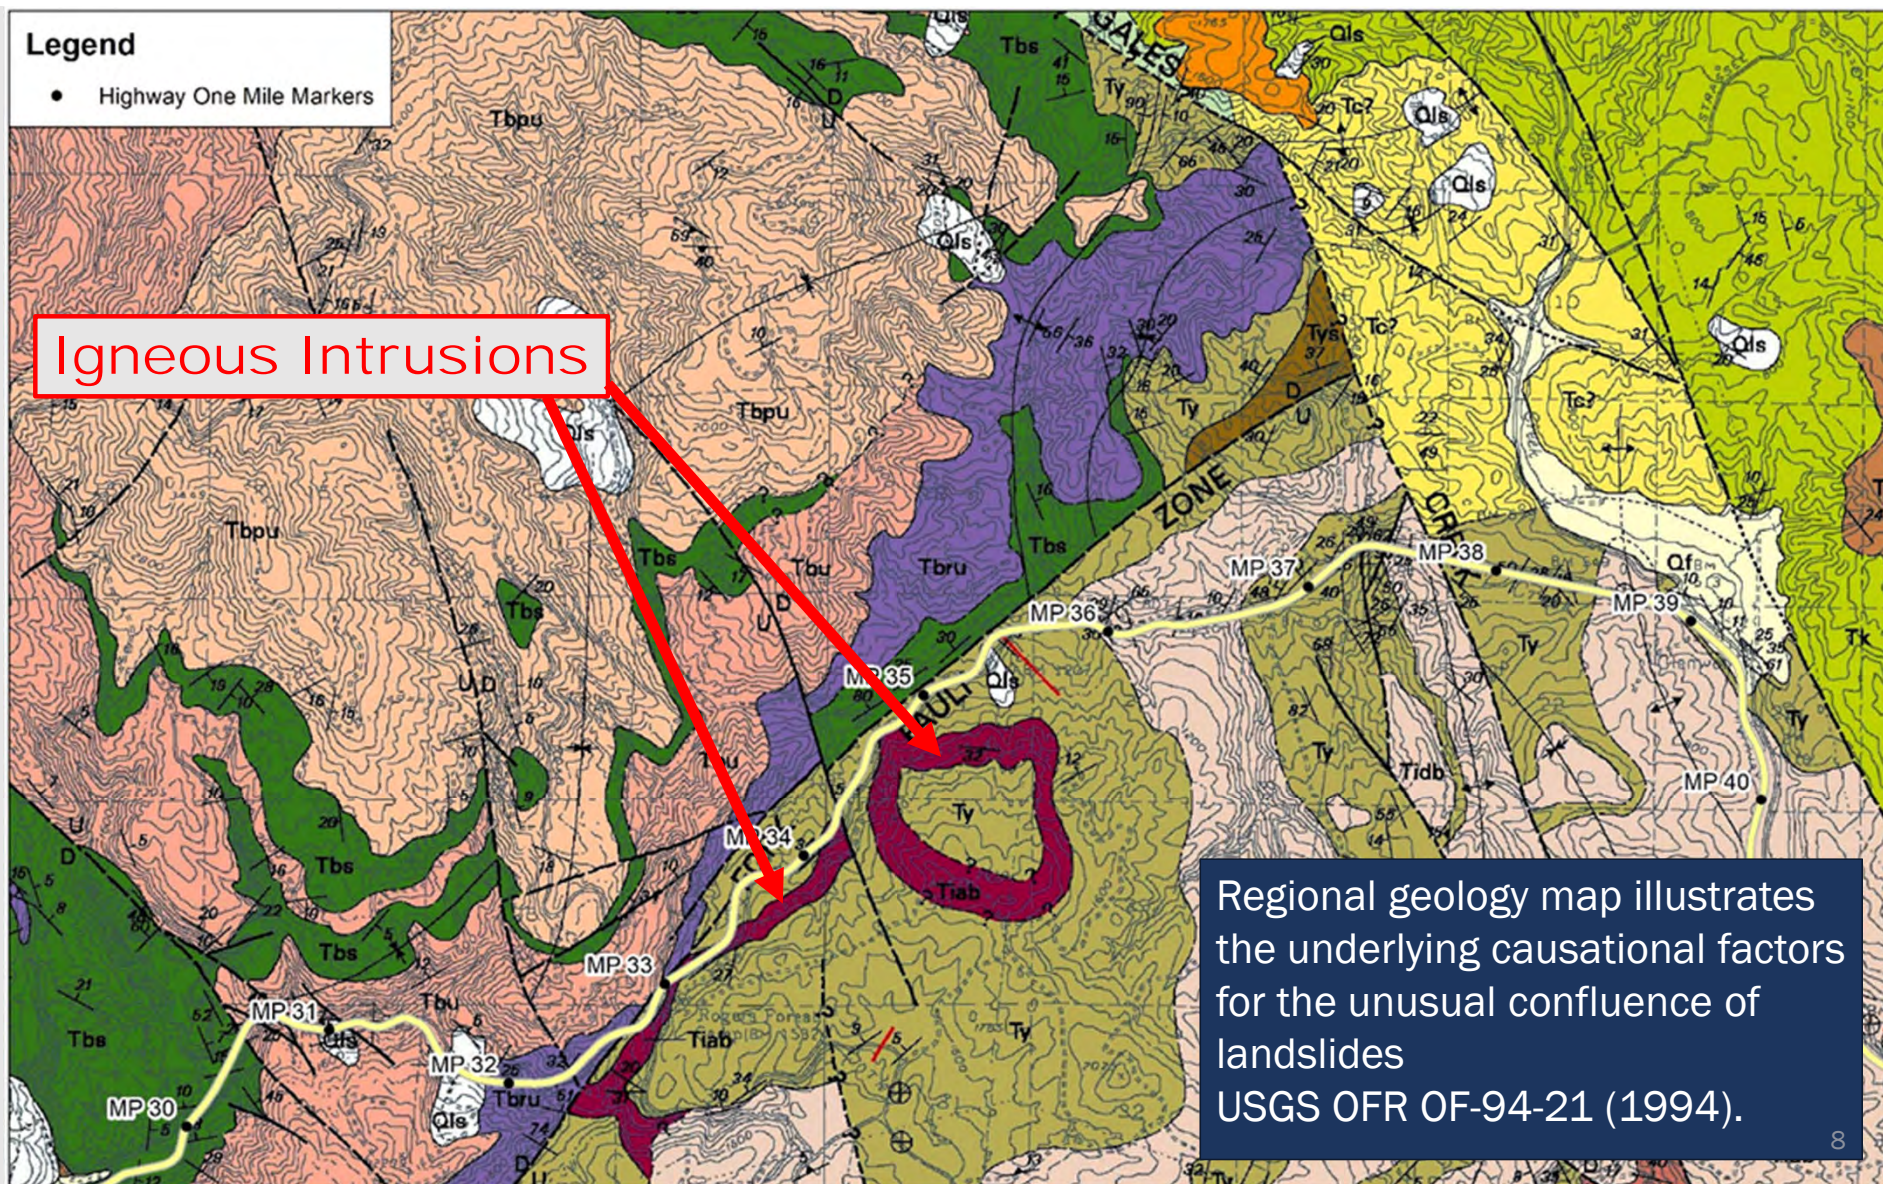
Igneous Intrusions

Regional geology map illustrates the underlying causal factors for the unusual confluence of landslides
USGS OFR OF-94-21 (1994).

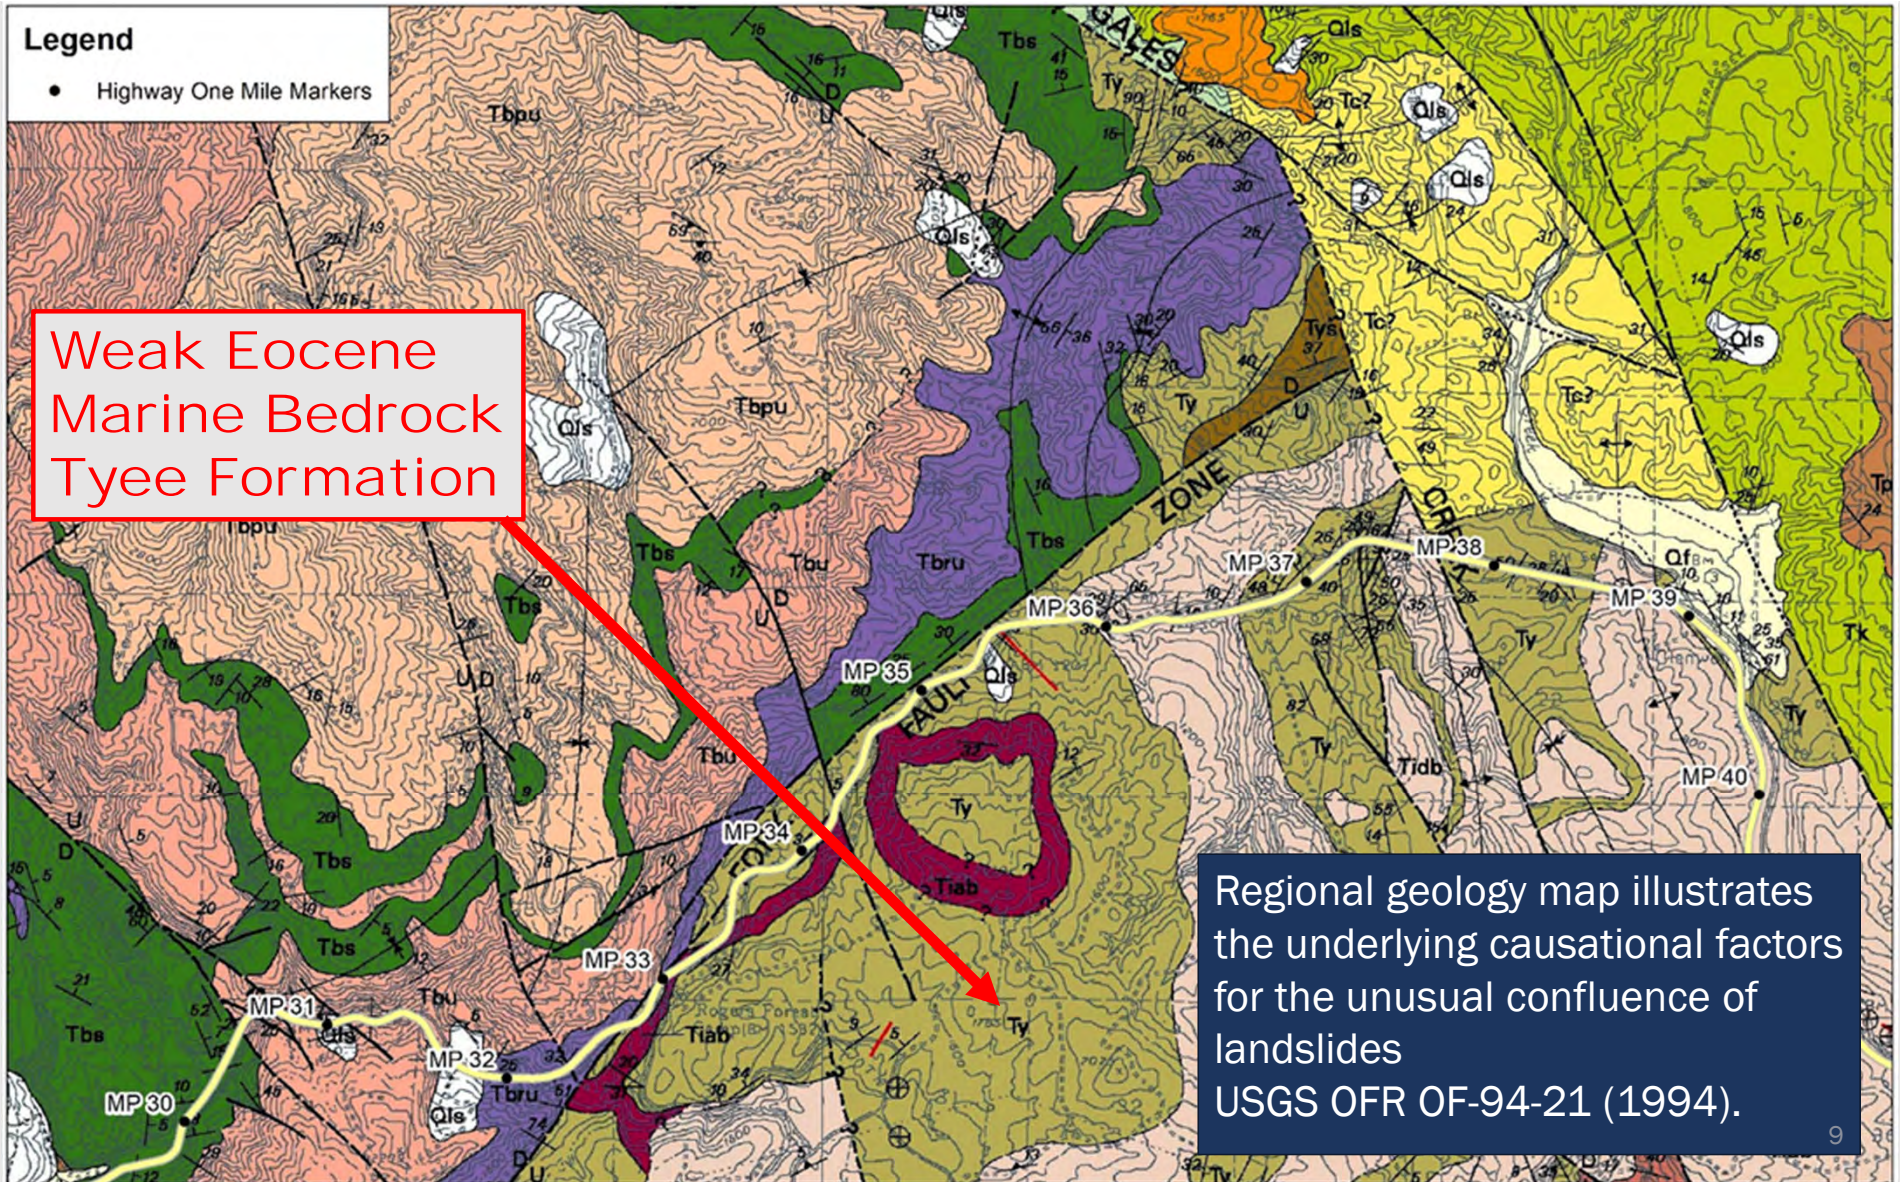
Weak Eocene
Marine Bedrock
Tyee Formation

Regional geology map illustrates the underlying causal factors for the unusual confluence of landslides
USGS OFR OF-94-21 (1994).

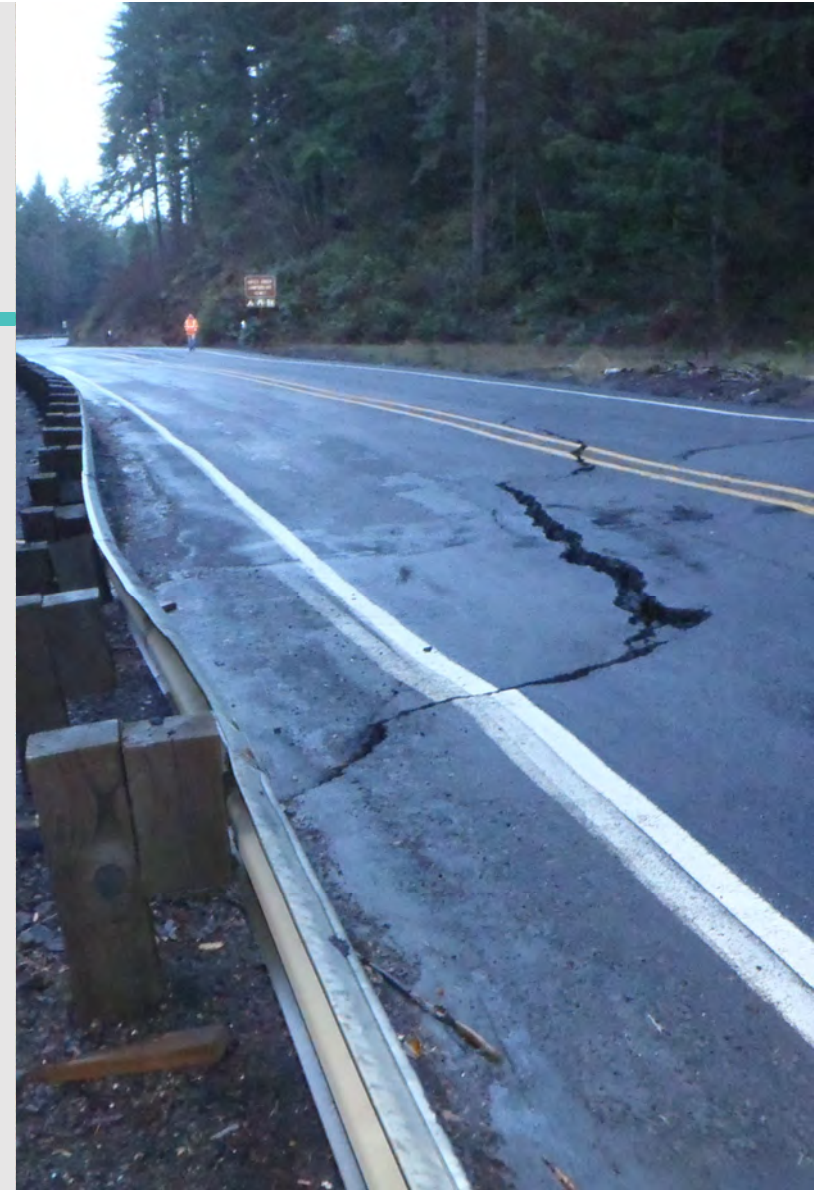
- Failures mapped as far back as 1939. Tillamook Burn 1933 to 1951. Highway developed during this time.
- Hand-excavated drainage tunnels at MP 34.8 circa 1956, now collapsing.
- Historic 1996 Floods caused extensive damage along the corridor (side image).
- Soldier Pile Walls installed at MP 33.25, 33.75 and 34.25 circa 2010 (total cost est. \$4.1 M).
- Light weight fill (i.e. sawdust) used to reduce soil loading in several locations. Sawdust fills now decomposing causing widespread settlement.

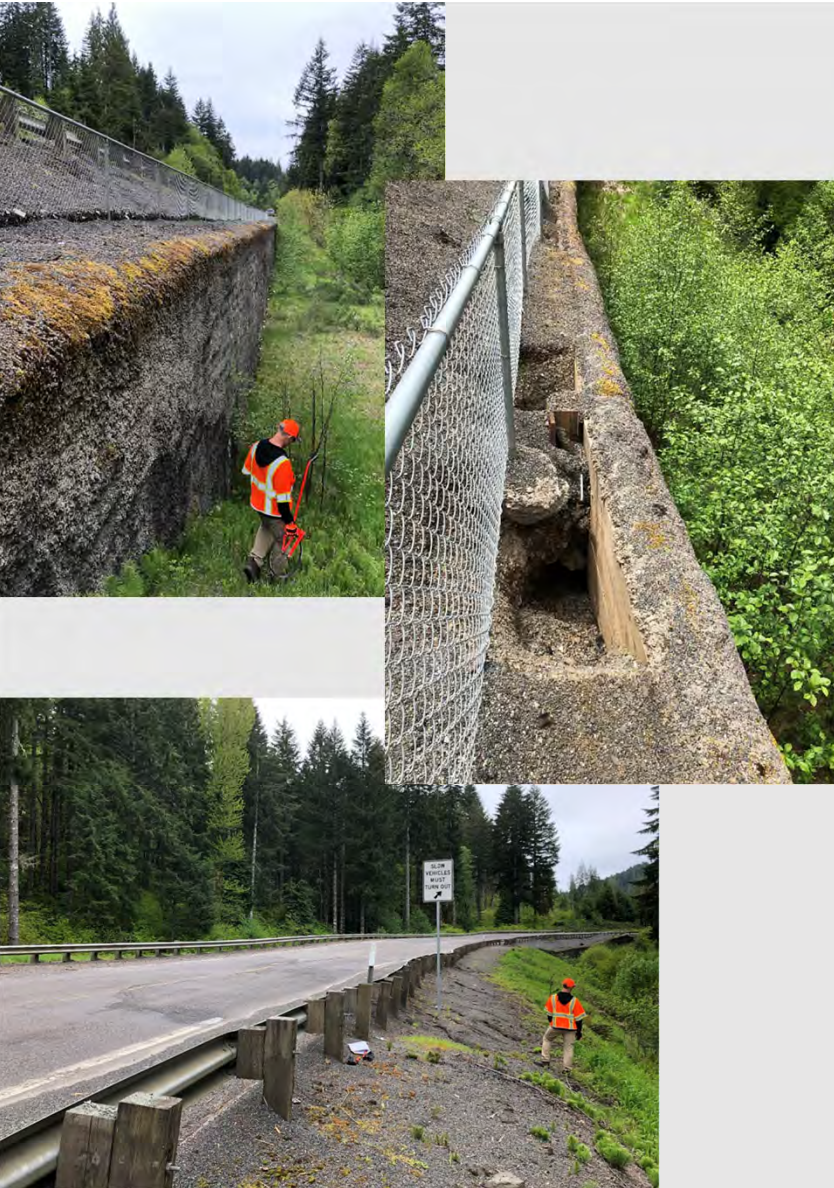
1996 Flood Damage

- 1996 associated rain events caused widespread damage along the OR6 corridor.
- Several partial roadway collapses occurred.
- Example images from MP 33.3.

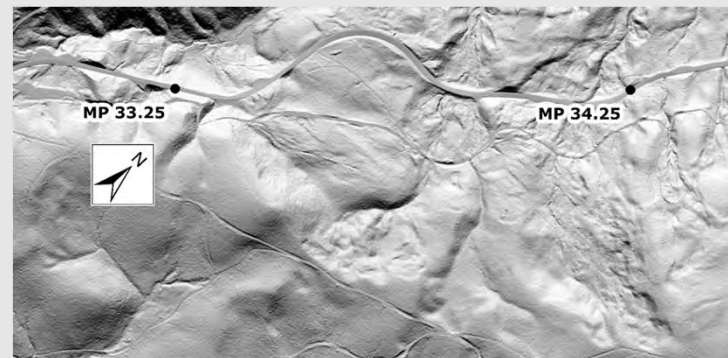
2010 Soldier Pile Walls

- Soldier Pile Walls installed circa 2010 for a total cost of ~\$4.1 M.
- MP 33.25 – 250 feet of wall.
- MP 33.75 – 230 feet of wall.
- MP 34.25 – 200 feet of wall.

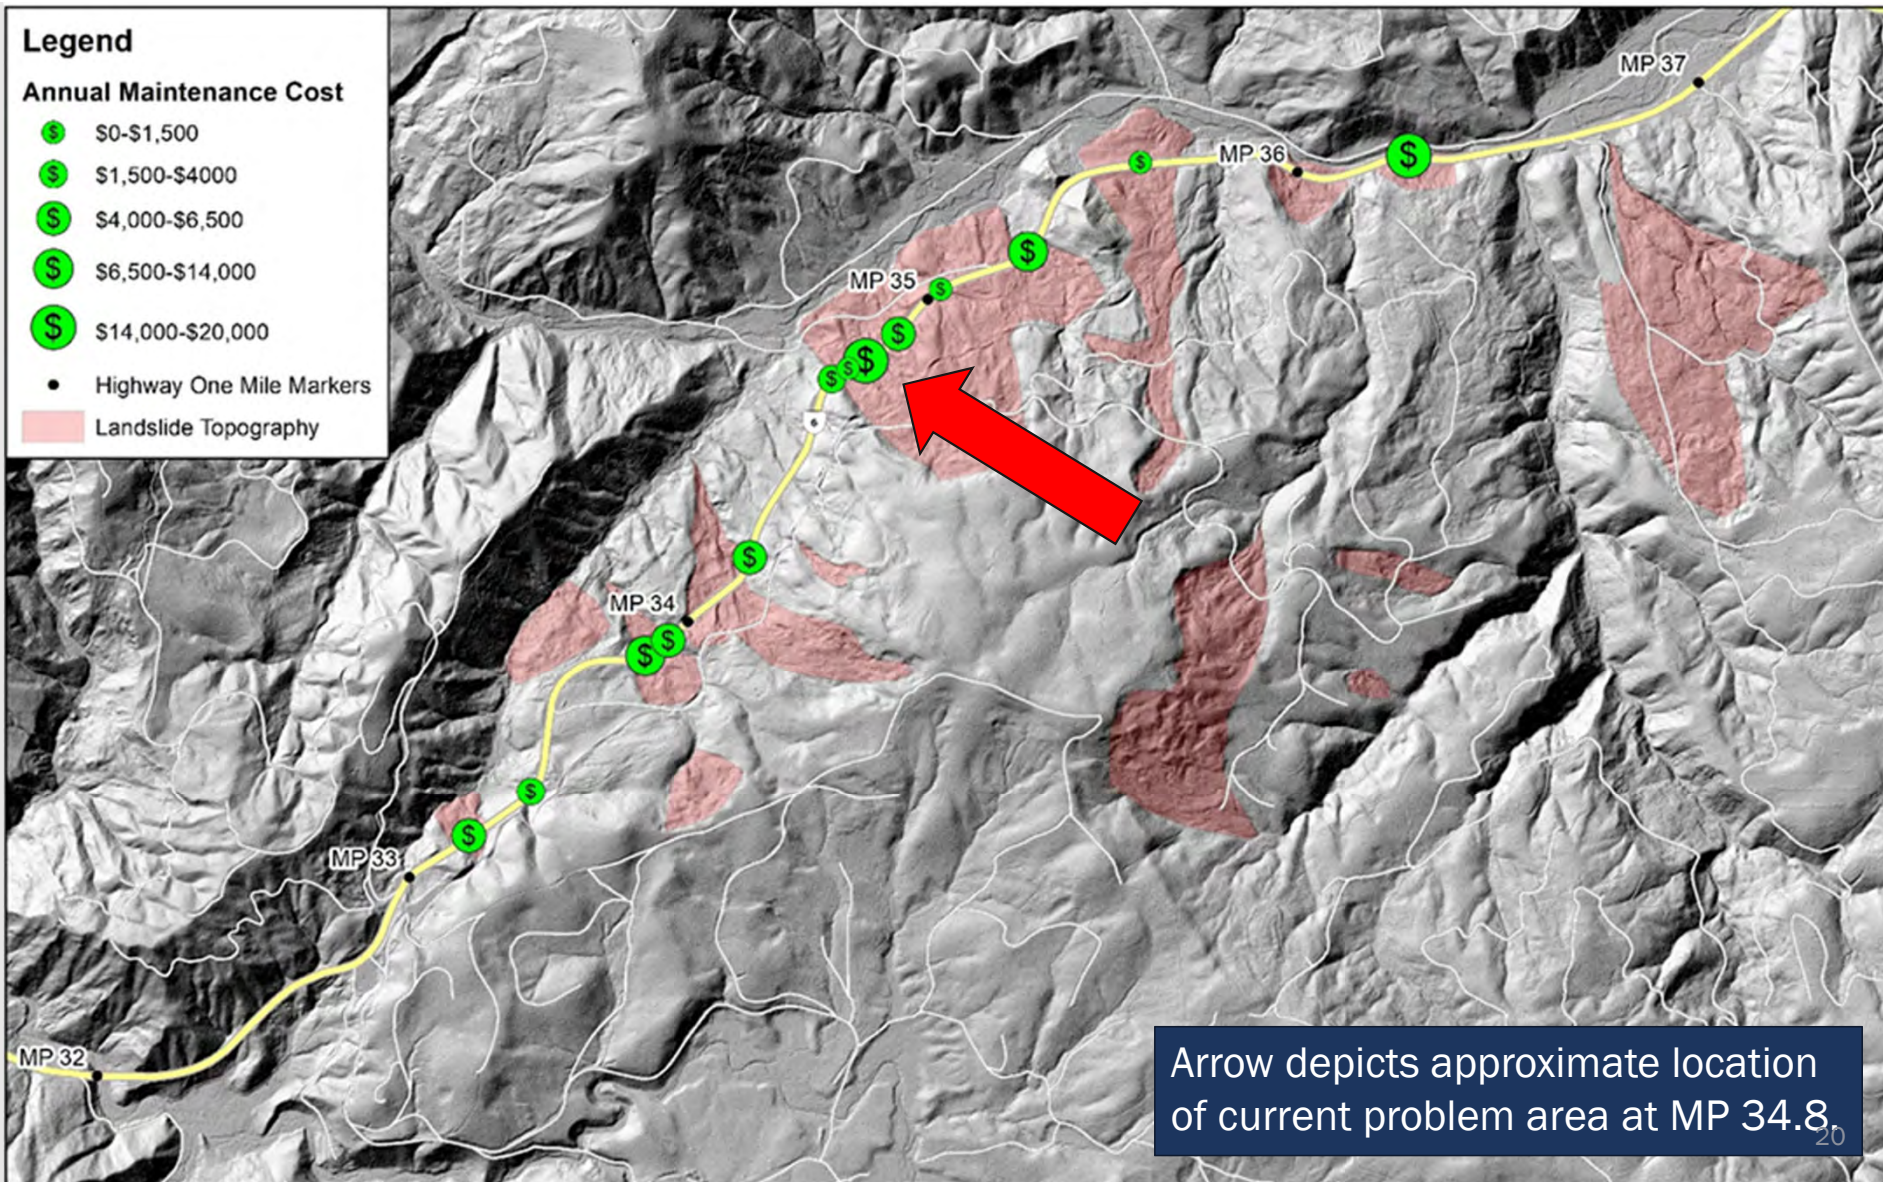
Arrow depicts approximate location
of current problem area at MP 34.8

This oblique LiDAR map illustrates relatively small size of the current problem area.

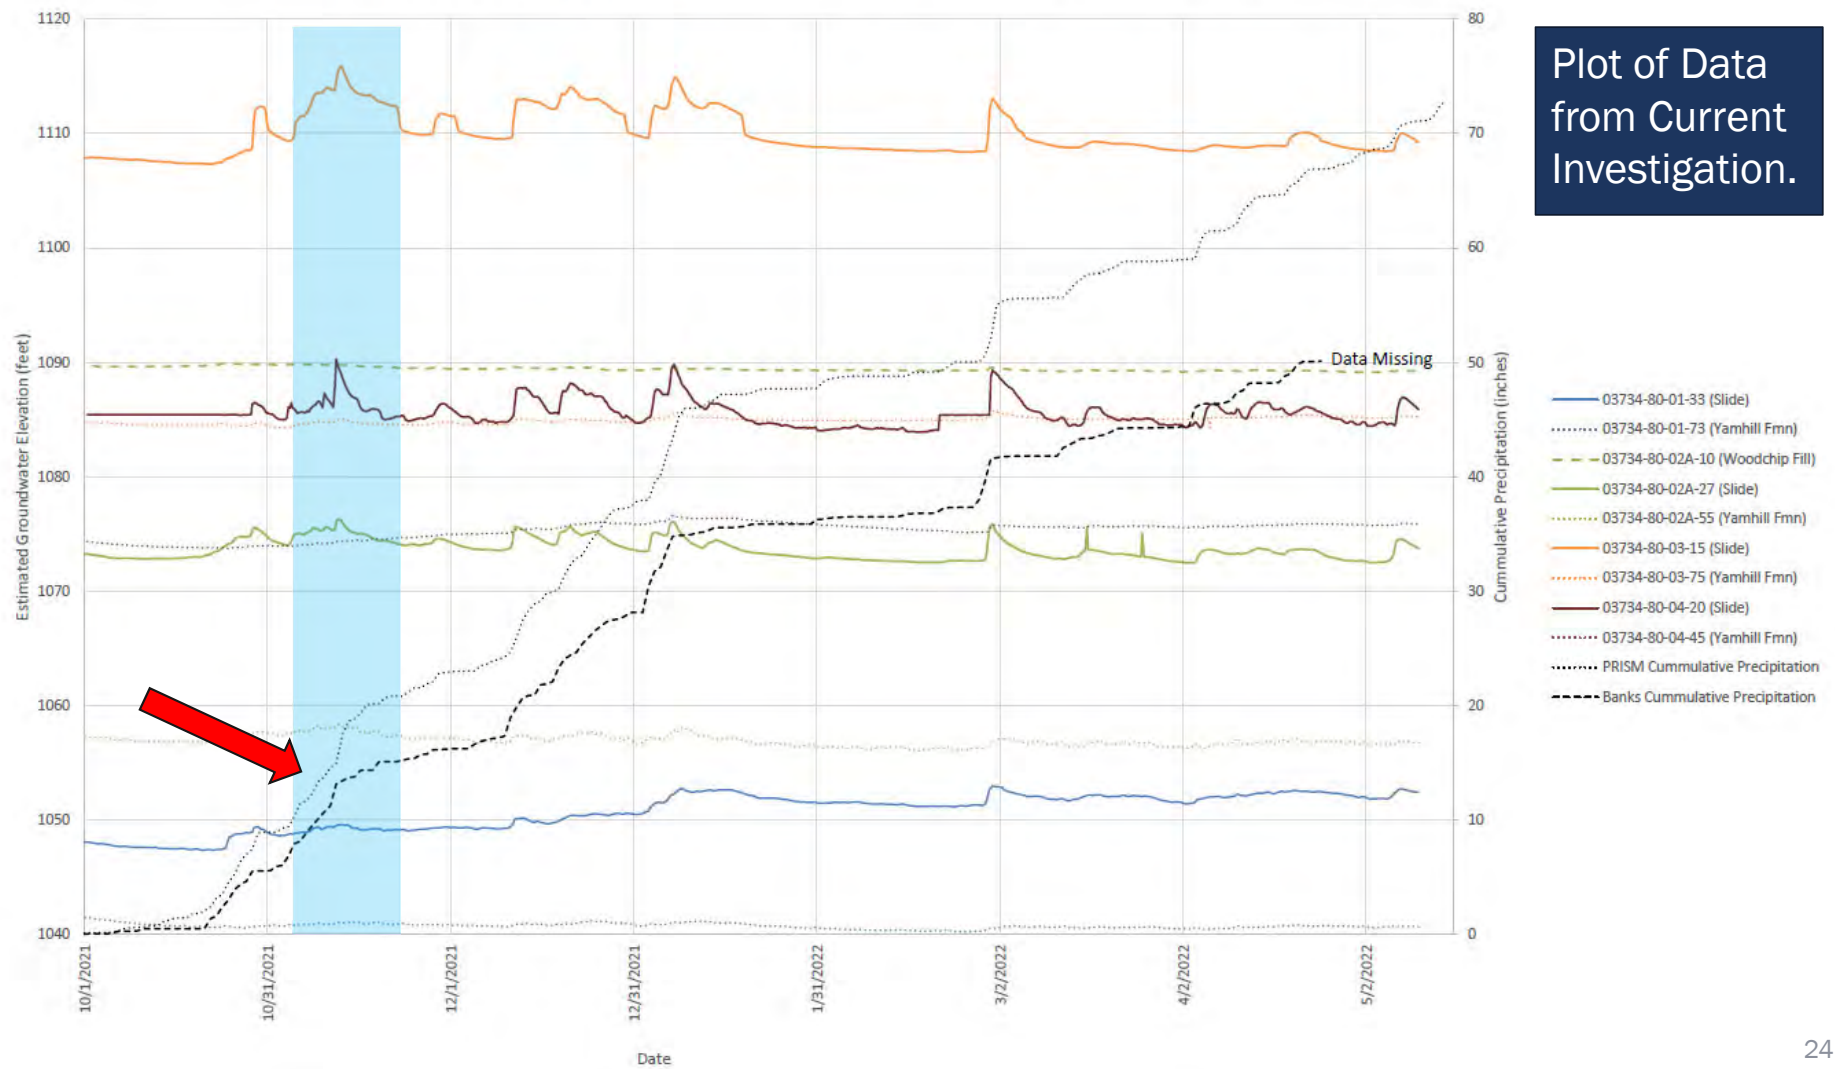
OR6 MP34.8 Groundwater Elevations and Cumulative Precipitation

- Rates of movement indicate pulses or surges on the order of 0.04 to as much as 0.28 inches per week (winter 2021 / 2022).
- Some instruments abandoned due to excessive movement.
- Example plot shows little movement from 09-23-2021 to 11-01-2021, movement increased by 11-17-2021, and then slowed thereafter.

Plot of Data from Current Investigation.

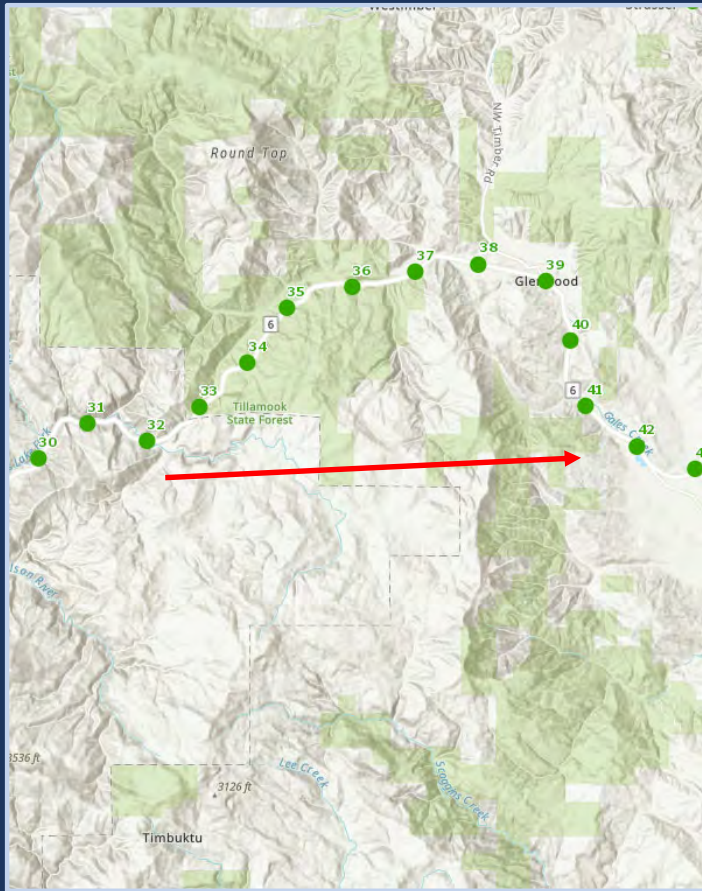
OR6 MP 32 to 37 Corridor Realignment

- A study is needed to find a suitable alignment, which balances environmental, geological, land acquisition, and external stakeholder interests.
- Substantial planning involvement.
- Substantial property acquisition.
- Significant investigation needs, potentially along multiple alignment alternatives.
- Realignment of OR6 corridor assumes that highway will increase in overall length relative to that existing.
- Estimated cost in the \$100's M.
